Global Industry Standard on Tailings Management (GISTM)

Public Disclosure Report

Hydro Alunorte

DRS1 and DRS2

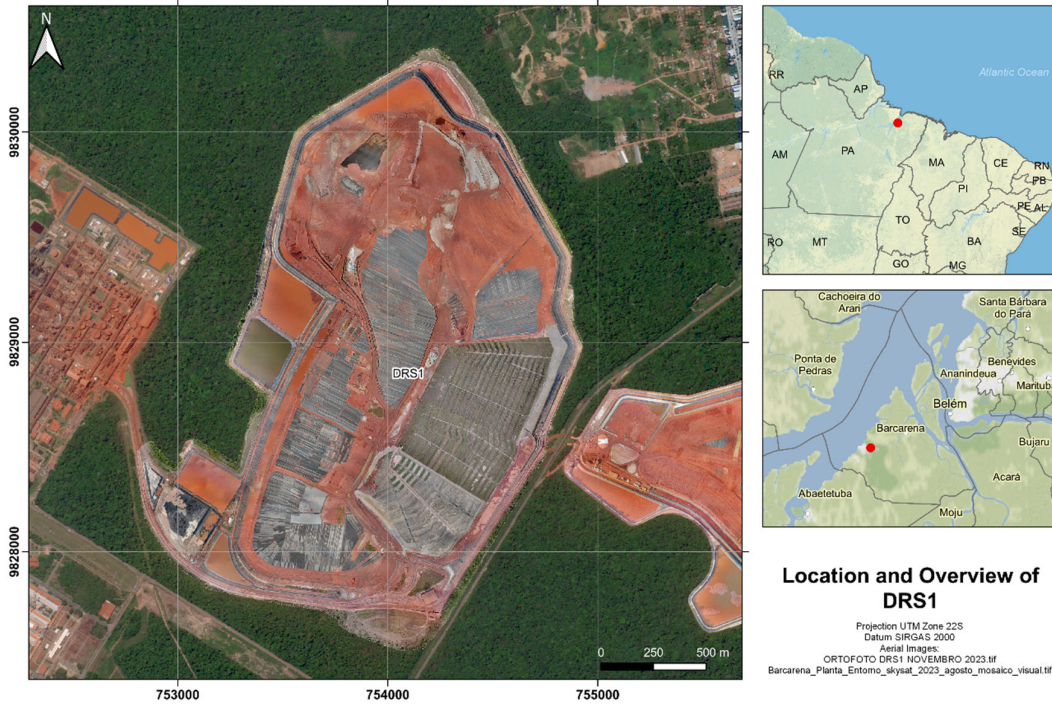
The water management system consists of surface drainage facilities and five basins connected to channels, spillways and pumping stations designed to manage the water levels during extreme rainfall events of 10.000-year return period. The water is treated in the Industrial Effluent Treatment Plant to guarantee the required environmental conditions are met before discharge. The disposal area, basins and channels are lined with HDPE geomembrane to avoid migration through foundation seepage.

DRS1 General Description	
Purpose	Storage of bauxite residue generated in alumina production
Current height	45.60 m
Final height	45.60 m
Volume of residue stored ³	61.43 Mm ³
Maximum residue storage capacity ⁴	64.83 Mm ³
Implementation stages ⁵	The facility was constructed in 1994 and 1995, and underwent 11 expansions (expansions 1, 2, 3, 4, 5, 6, 7, South cell, East cells CL1, CL2, and CL3).
Current status	In operation, with progressive closure and rehabilitation
Consequence classification ⁶	Very high

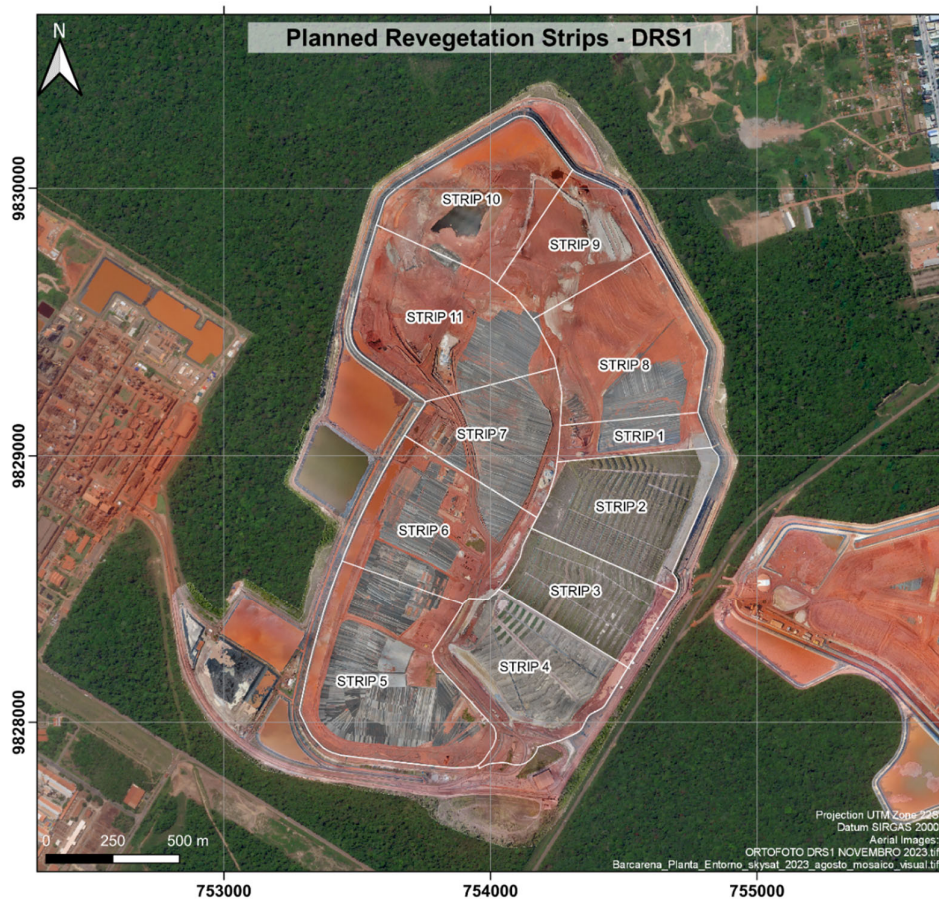
The closure is divided in 11 strips of rehabilitation. The strips 2, 3 and 4 have been rehabilitated, and represent approximately 57 ha. The design considers cap and store the residue with cover systems consisting of HDPE geomembrane, densified soil, and revegetation of the surface.

The image below shows the configuration of DRS1 with the proposed revegetation strips.

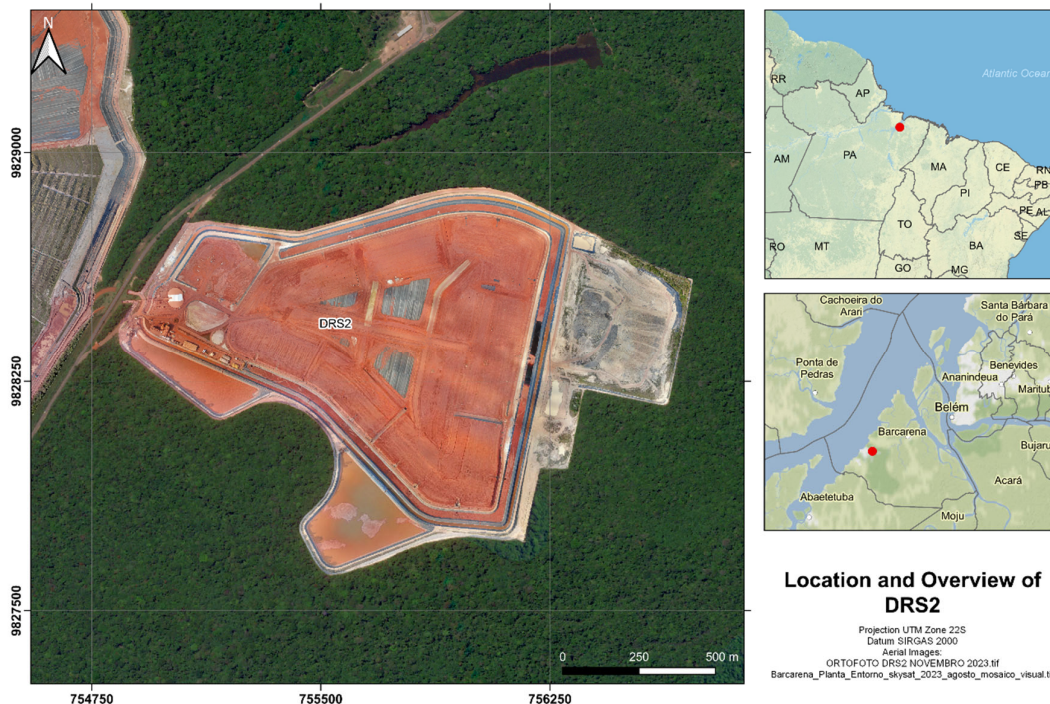
The disposal area, basins and channels are lined with HDPE geomembrane to mitigate risk of migration through foundation seepage.

DRS2 General Description	
Purpose ⁷	Storage of bauxite residue generated in alumina production
Current height ⁸	24.00 m
Final height ⁹	71.00 m
Volume of residue stored ¹⁰	5.71 Mm ³
Maximum residue storage capacity	24.63 Mm ³
Implementation stages ¹¹	Singles stage construction, 2015.
Current status	In operation
Consequence classification ¹	Very high
Estimated year of closure	2031*

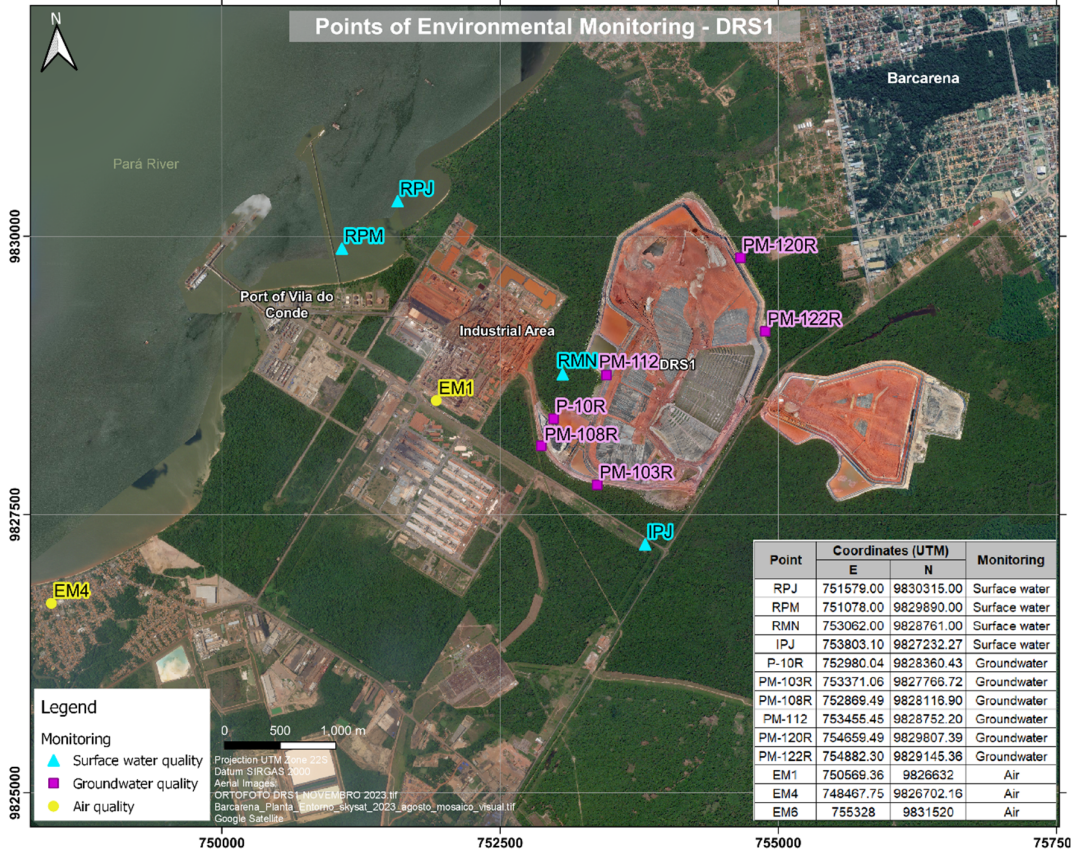
Surface water quality

There are four monitoring points to assess surface water parameters potentially related to DRS1 activities. The monitoring is performed by third parties and the results are reported to the regulator through the annual RIAA, in compliance with the operational license. A small number of the monitored parameters indicate deviations. The RIAA indicates that these deviations are due either to the natural hydrogeological conditions of the region or anthropic sources outside of Hydro Alunorte’s property limits.

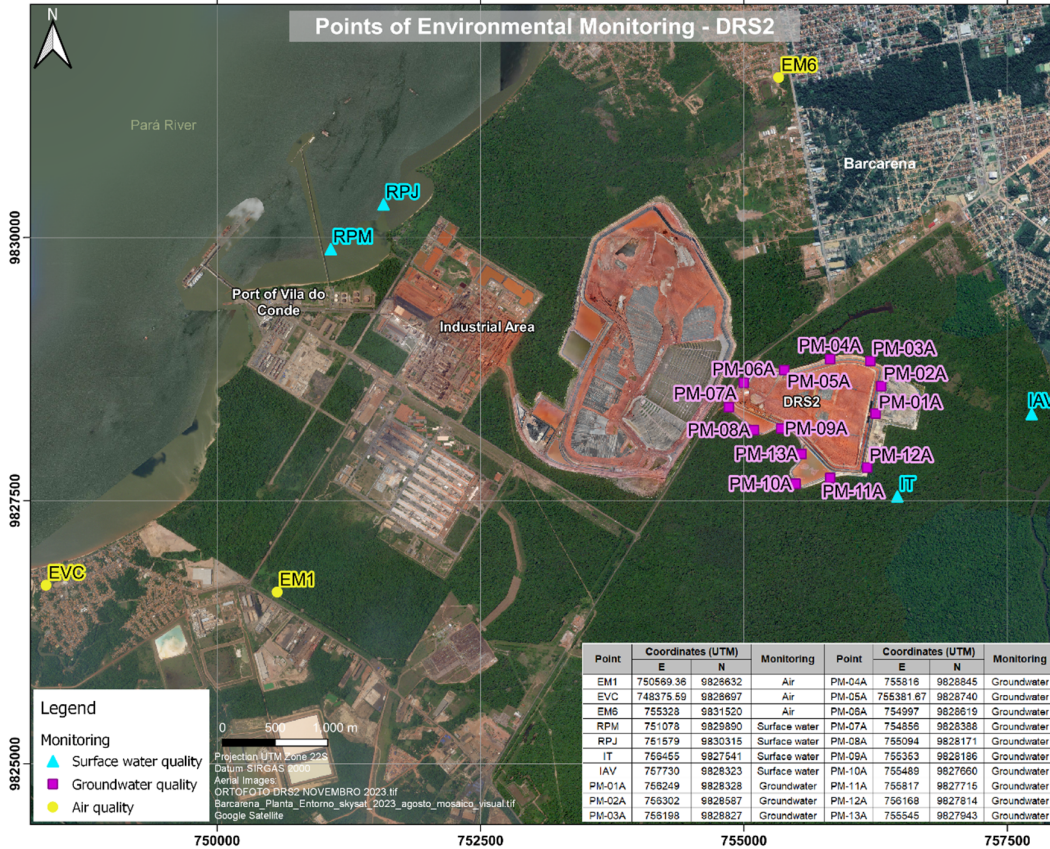
Surface water quality

There are four monitoring points to assess surface water parameters potentially related to DRS2 activities. The monitoring is performed by third parties and the results are reported to the regulator through the annual RIAA, in compliance with the operational license. A small number of the monitored parameters indicate deviations. The RIAA indicates that these deviations are due either to the natural hydrogeological conditions of the region or anthropic sources outside of Hydro Alunorte’s property limits.

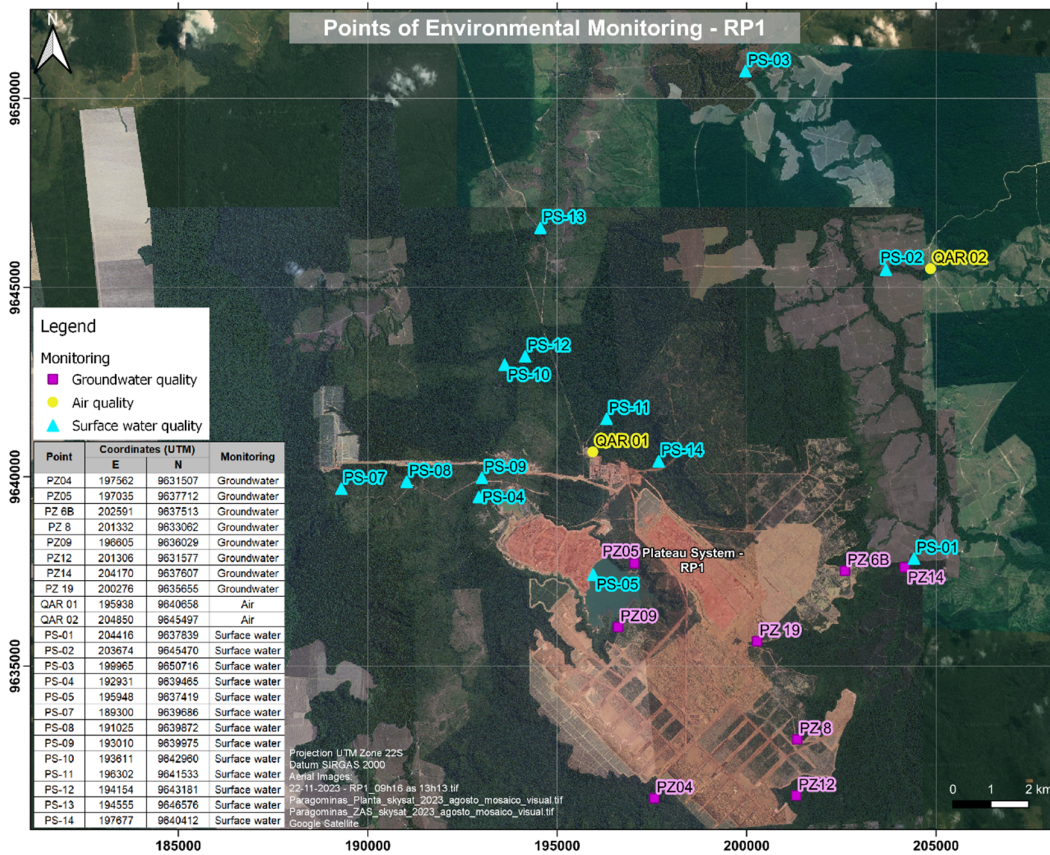
Surface water quality

TDA is located on the Miltônia 3 Plateau and is delimited by the Parariquara and Cachoeirinha catchment basins. There are thirteen monitoring points to assess surface water quality parameters potentially related to TDA operations.

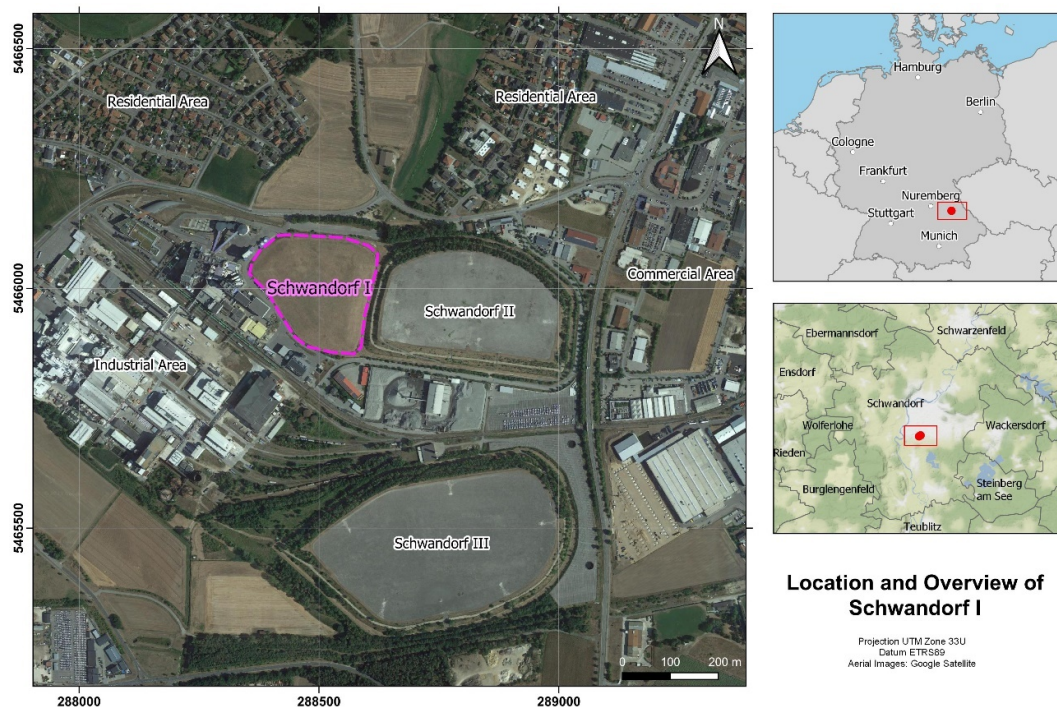
The Schwandorf I tailings facility (TF) is located in Schwandorf, Bavaria, Germany. It began operating in 1936 for the purpose of storing bauxite residue, and it was closed in 2009.

Schwandorf I Information	
Tailing type	Bauxite residue
Maximum height (m)	18
Size (Ha)	4.5
Volume (m ³)	600,000
Rising method	Stock piled (dry deposited)
Current status	Closed
Lifetime	1936 - 1957
Consequence classification	High

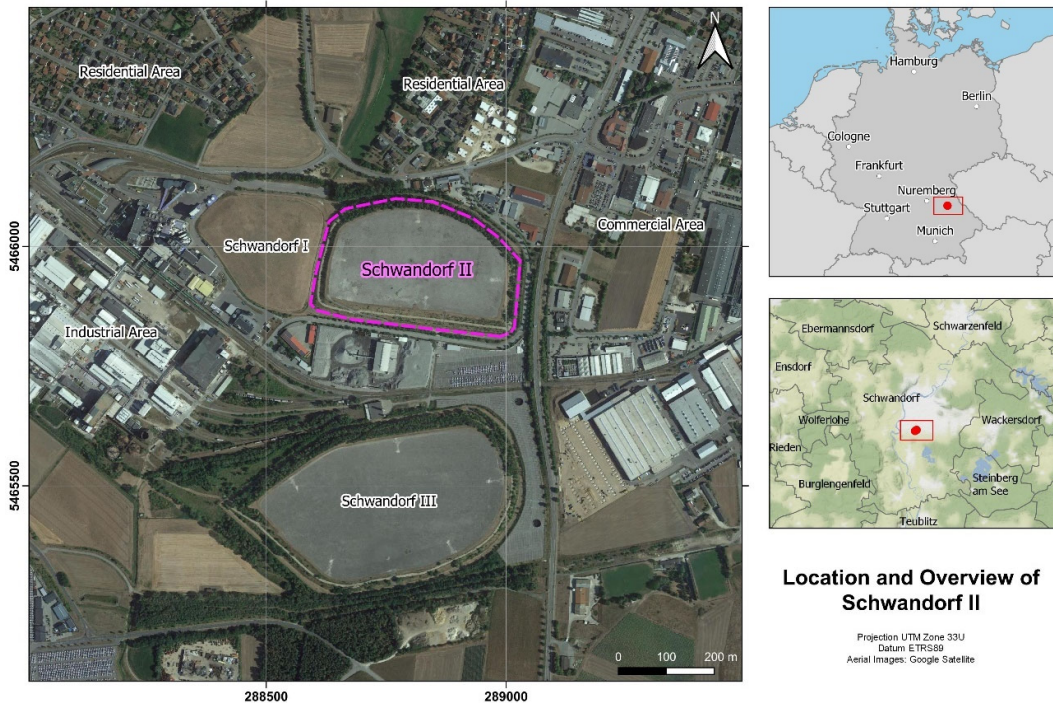
The Schwandorf II TF is located in Schwandorf, Bavaria, Germany. It began operating in 1956 for the purpose of storing bauxite residue and it was closed in 2009.

Schwandorf II Information	
Tailing type	Bauxite residue
Maximum height (m)	16
Size (Ha)	9.9
Volume (m ³)	1,500,000
Rising method	Upstream design
Current status	Closed
Lifetime	1956 - 1973
Consequence classification	High

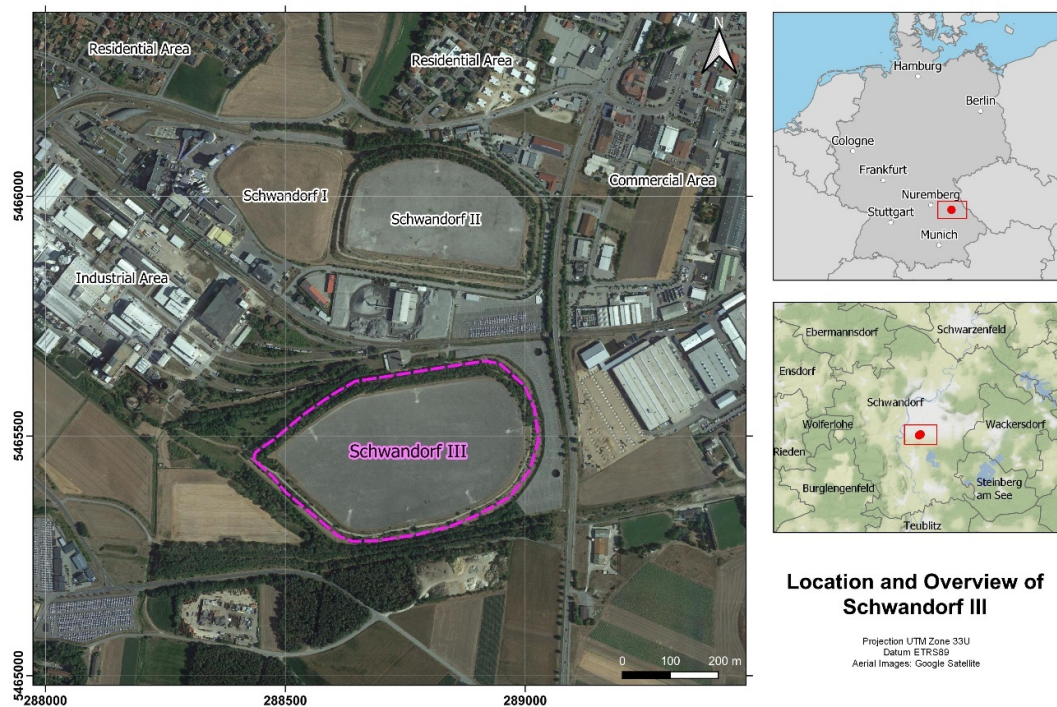
The Schwandorf III TF is located in Schwandorf, Bavaria, Germany. It began operating in 1936 for the purpose of storing bauxite residue and it was closed in 2009.

Schwandorf III Information	
Tailing type	Bauxite residue
Maximum height (m)	18
Size (Ha)	15.9
Volume (m ³)	3,000,000
Rising method	Upstream design
Current status	Closed
Lifetime	1936 - 1994
Consequence classification	High

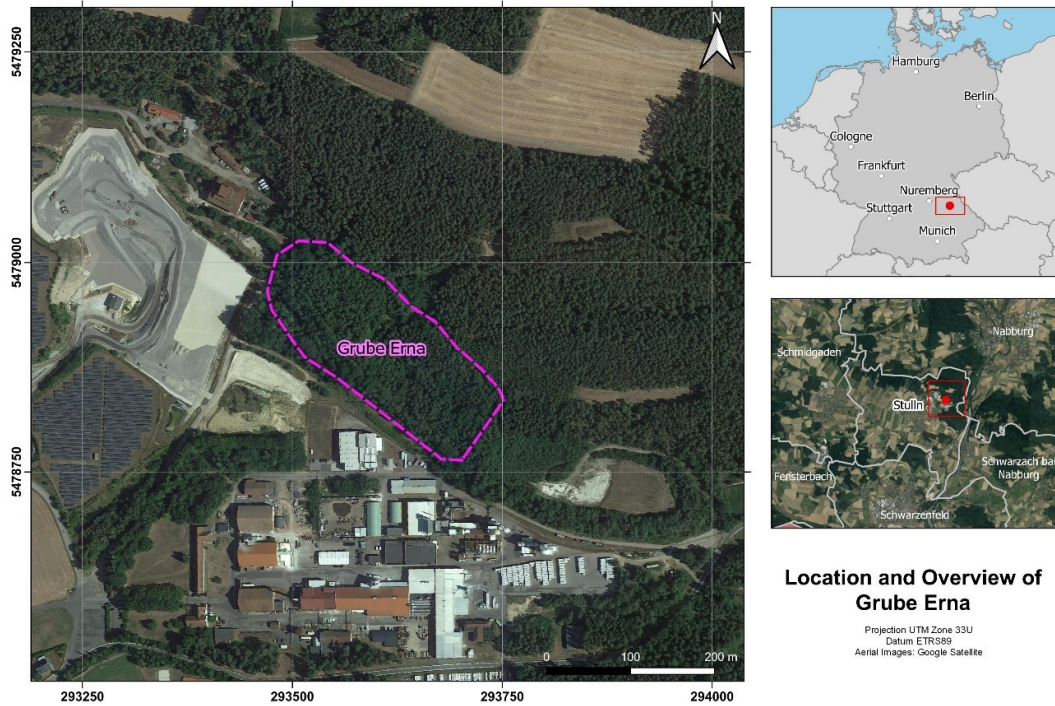
Grube Erna I & II

Grube Erna Tailings I&II began operating in 1933 for the purpose of storing flotation sand from the processing of fluorite. The facility was closed in 1981.

Grube Erna Information	
Tailing type	Flotation sand
Maximum height (m)	9
Size (Ha)	4.7
Volume	130.000
Rising method	Upstream design
Current status	closed
Lifetime	1933-1981
Consequence classification	Significant

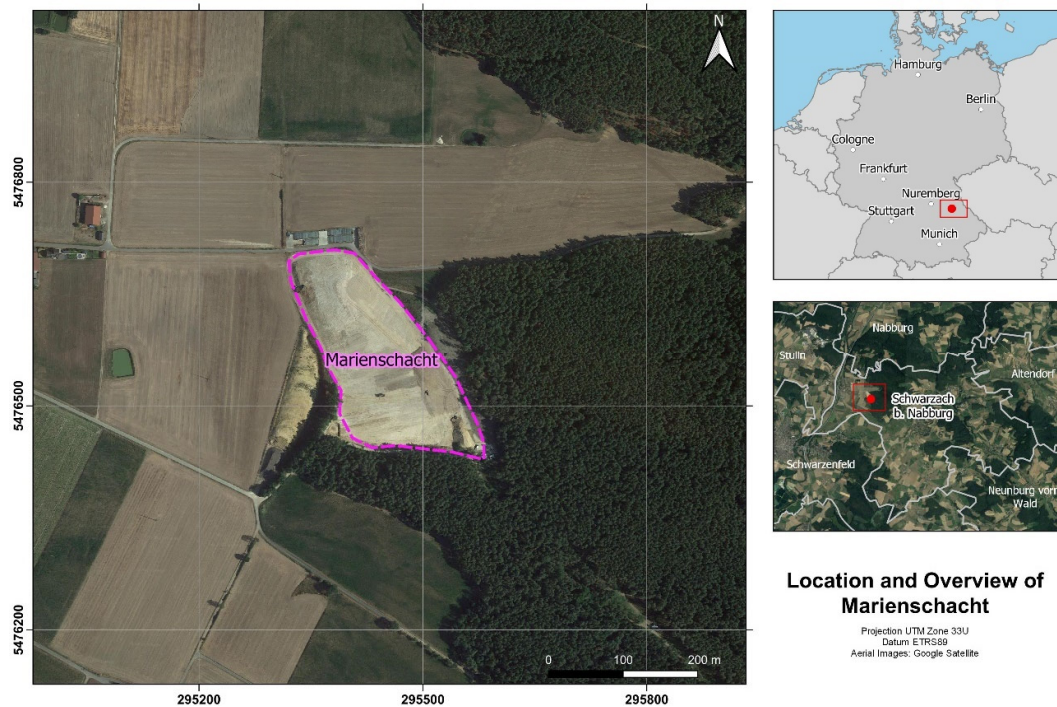
Marienschacht Halde

The Marienschacht tailings facility is located in Wölsendorf, Bavaria, Germany. The Marienschacht tailings facility began operating in the 1930s for the purpose of depositing sand from fluorite processing. The facility was closed in 1968.

Marienschacht Information	
Tailing type	Flotation sand
Maximum height (m)	18
Size (Ha)	4.6
Volume (m ³)	133,000
Rising method	Upstream design
Current status	Closed
Lifetime	1930-1980
Consequence classification	Low
